Precoated femoral stem with no subsidence

~ A 5 year RSA follow-up ~

Söderlund P, Röhrl S, Nilsson K G, Nivbrant B*

University of Umeå, Sweden, *University of Western Australia

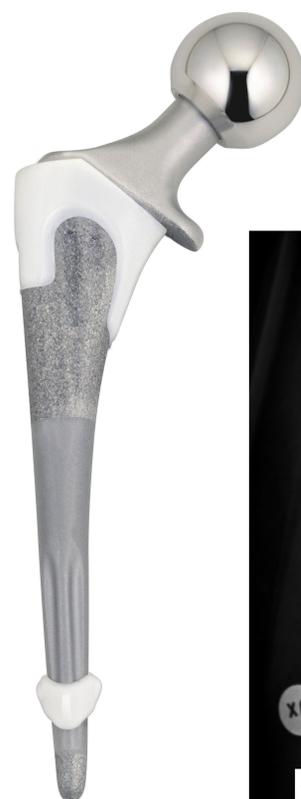
The Definition pre-coated stem

The stem studied was the Definition PM[®] (Stryker). This is a collared chromium-cobalt stem with a straight rectangular geometry and a distal circular cross-section with rounded corners. It has rough gritblasted proximal and distal surfaces and a proximal PMMA mantle which, according to the manufacturer, is 86 times stronger than hand-mixed cement. The stem also has a distal centralizer. The stem was inserted with vacuum mixed Palacos-gentamicin bone-cement using 3rd generation cementing technique.

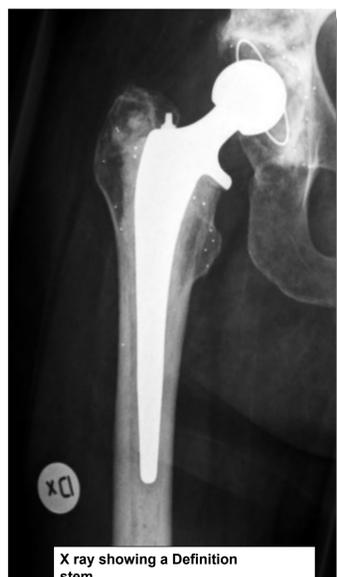
X ray showing a Definition stem. The white dots are tantalum spheres in the femur and the cement used for RSA
